CAFO FACILITY INSPECTION REPORT

INSPECTOR(S): Anthony D'Angelo (PG Environmental, LLC)

04/11/2013
ACTUAL INSPECTION DATE

TIVA Dairy
FACILITY NAME

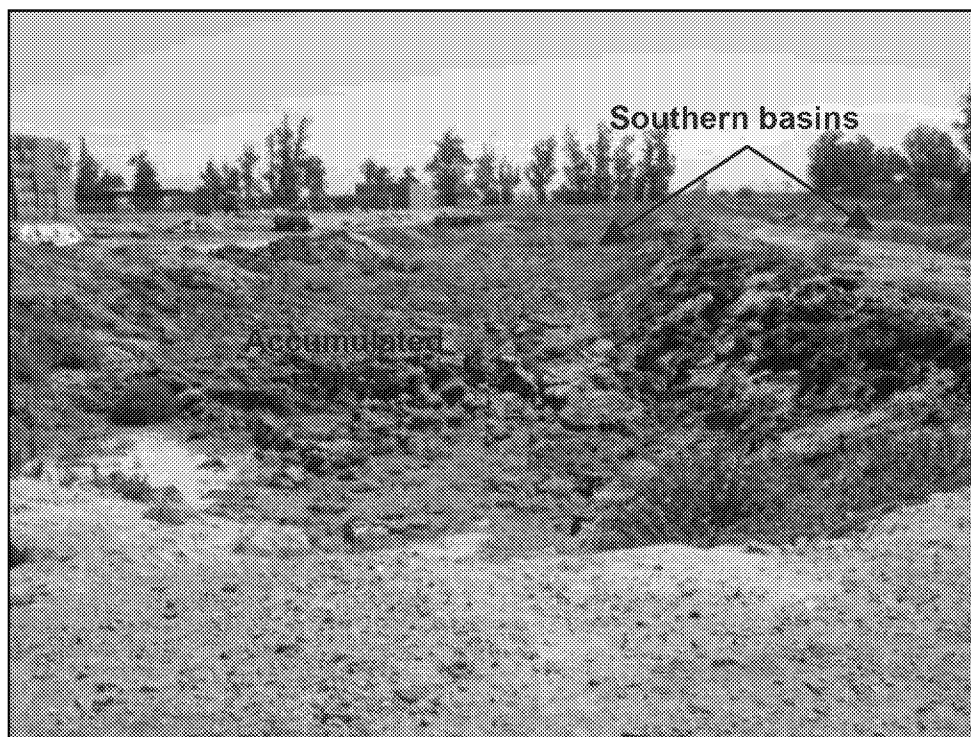
1. Depth markers were not installed in all basins at the Facility as required by Permit Attachment B - Monitoring and Reporting Program, Section I.B.1 (refer to Photos 4 through 7, and 15).

3. The EWMP was not fully implemented onsite and the containment structures had not been adequately maintained at the Facility as required by the Permit. Section V - "Operation and Maintenance" of the EWMP states that "lagoon solids should be removed every summer to ensure full capacity in the lagoons before the start of the next winter season." Mr. Vander Meulen stated that the Facility containment structures were last cleaned in 2012; however, had only been cleaned "a couple of times" in the eight (8) years the dairy had been in operation. Accumulated solids were observed in three (3) of the southern basins (refer to Photos 4 and 5). As a result, the Discharger was not fully implementing the EWMP onsite at the Facility. Provision VII.C.3.a of the Permit states that "the discharger shall design, construct and maintain containment structures to retain all wastewater within the facility, including all process wastewater and all precipitation on, and drainage through, manured areas resulting from rainfall up to and including a 25-year, 24-hour rainfall event." Provision VII.C.3.b of the Permit states that "the discharger shall develop and fully implement an Engineered Waste Management Plan (EWMP) acceptable to the Executive Officer." The Discharger shall design and maintain all containment structures and fully implement the EWMP as required by Provision VII.C.3.b of the Permit.

3. The inspector observed, during the inspection, accumulated solids in the basins located in the southern portion of the Facility (refer to Photos 4 and 5). Mr. Vander Meulen stated that all Facility containment structures were last cleaned in 2012, and had been cleaned "a couple times" in the eight (8) years the Facility has been in operation. In addition, the inspector observed pond solids stockpiled on the earthen berms between the basins (refer to Photos 6, 8, and 9). As a result, the overall capacity of the containment structures at the Facility may be diminished. Provision VII.C.3.a of the Permit states that "the discharger shall design, construct and maintain containment structures to retain all wastewater within the facility, including all process wastewater and all precipitation on, and drainage through, manured areas resulting from rainfall up to and including a 25-year, 24-hour rainfall event." The Discharger must design and maintain all containment structures per the EWMP as required by Provisions VII.C.3.a of the Permit.

Photograph 4. View facing east of the southern basins constructed in field No. 1, basin No. 1, and basin No. 2 (refer to Exhibit 1). Note the accumulated solids in the basin, and that the basins did not contain depth markers.

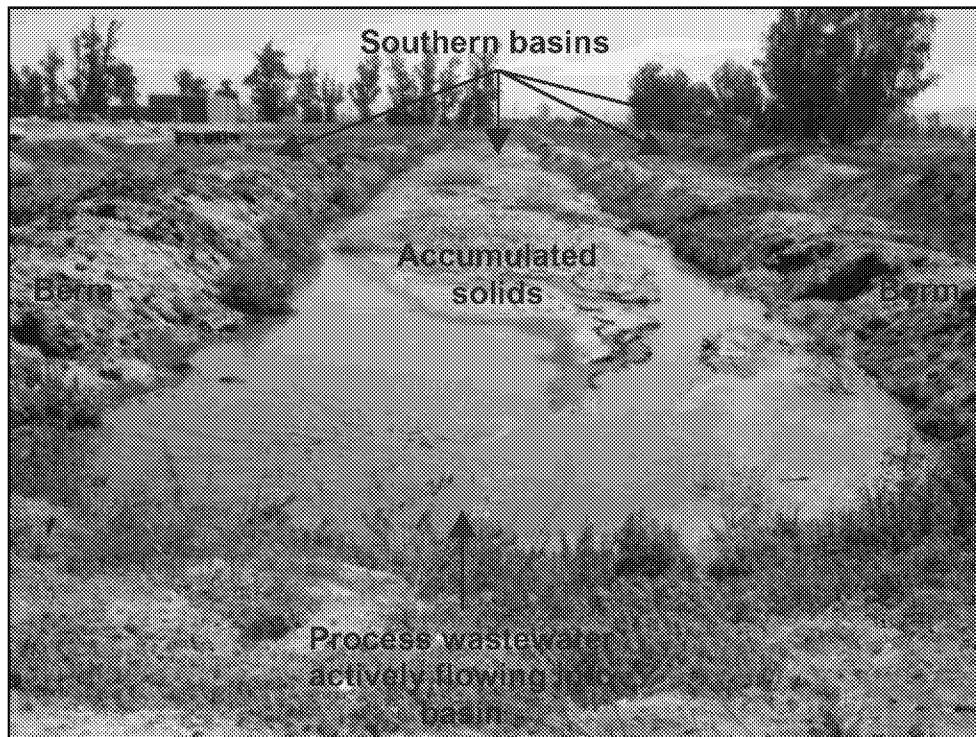
Photograph 5. View facing east of the southern basins. Process wastewater was actively flowing into the northern-middle basin. Note the accumulated solids in the basin. Also note the basins did not contain depth markers.

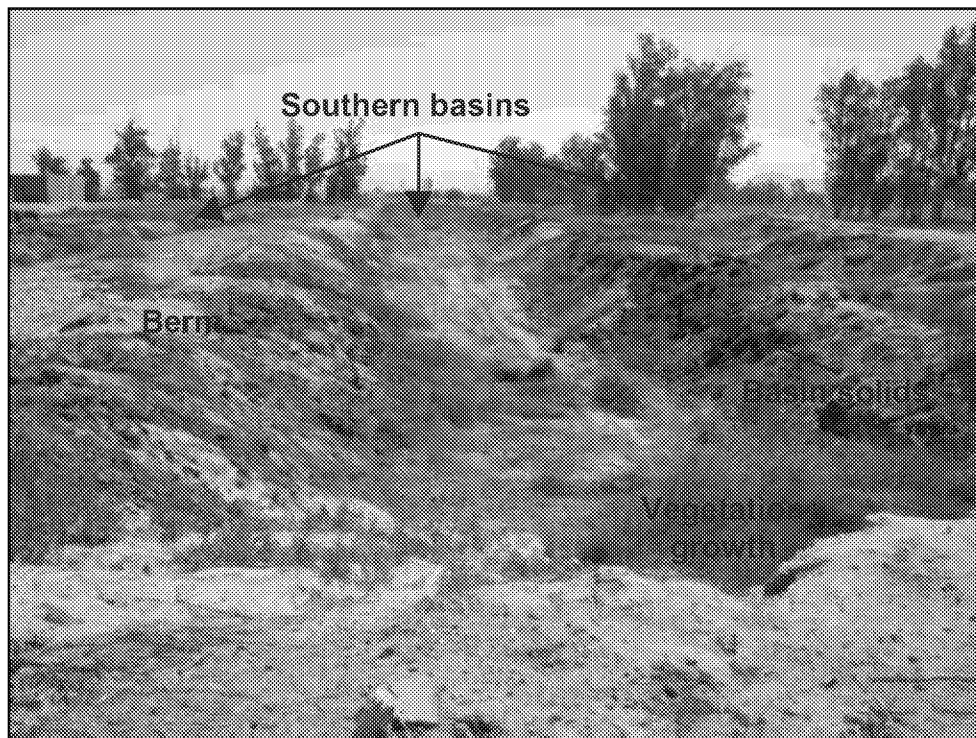
2. The inspector observed, during the inspection, that previously removed basin solids had been stockpiled on the earthen berms of the basins located in the southern portion of the Facility (refer to Photos 6, 8, and 9). Mr. Vander Meulen stated that the southern basins were last cleaned of accumulated solids in 2012. Provision VII.C.5.c of the Permit states "no containment structures shall be constructed of manure, and manure shall not be used to improve or raise existing containment structures."

4. The inspector observed, during the inspection, that vegetation growth potentially affecting the containment structure capacity was observed in all Facility containment structures (refer to Photos 6, 7, 10, 11, and 12). As a result, the overall capacity of the containment structures at the Facility may be diminished. Provision VII.C.3.a of the Permit states that "the discharger shall design, construct and maintain containment structures to retain all wastewater within the facility, including all process wastewater and all precipitation on, and drainage through, manured areas resulting from rainfall up to and including a 25-year, 24-hour rainfall event." The Discharger must design and maintain all containment structures per the EWMP as required by Provisions VII.C.3.a of the Permit.

Photograph 6. View facing east of the southern basins. Note previously removed basin solids were observed on the berms between the basins. Also note the basins did not contain depth markers and was observed with vegetation growth.

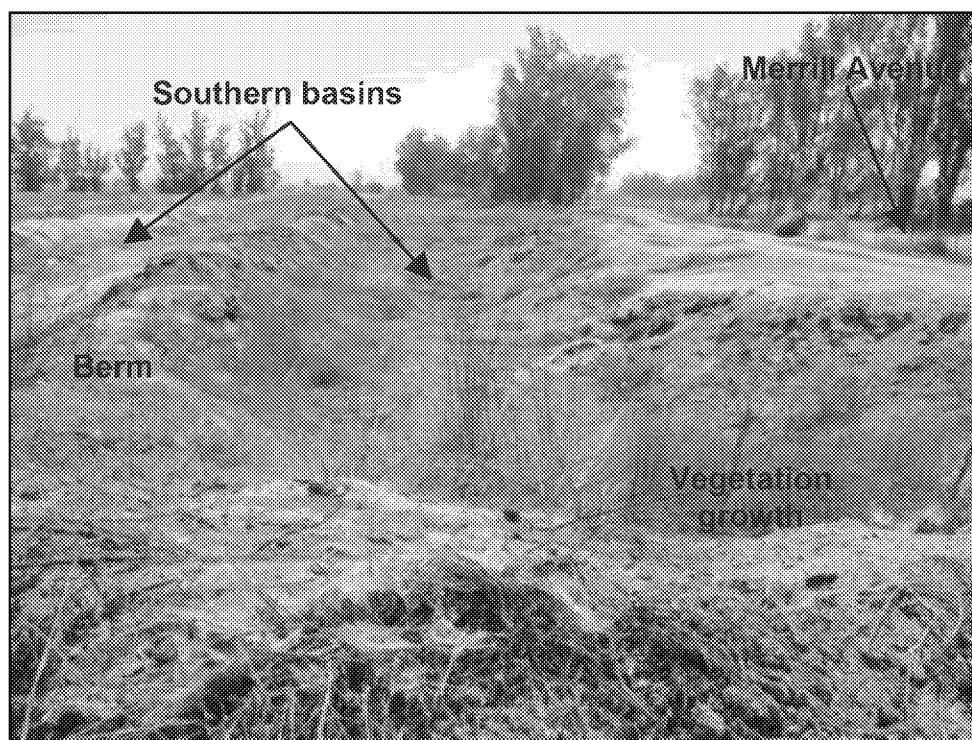
Photograph 7. View facing east of the southern-most southern basin. Note the basins did not contain depth markers and was observed with vegetation growth.

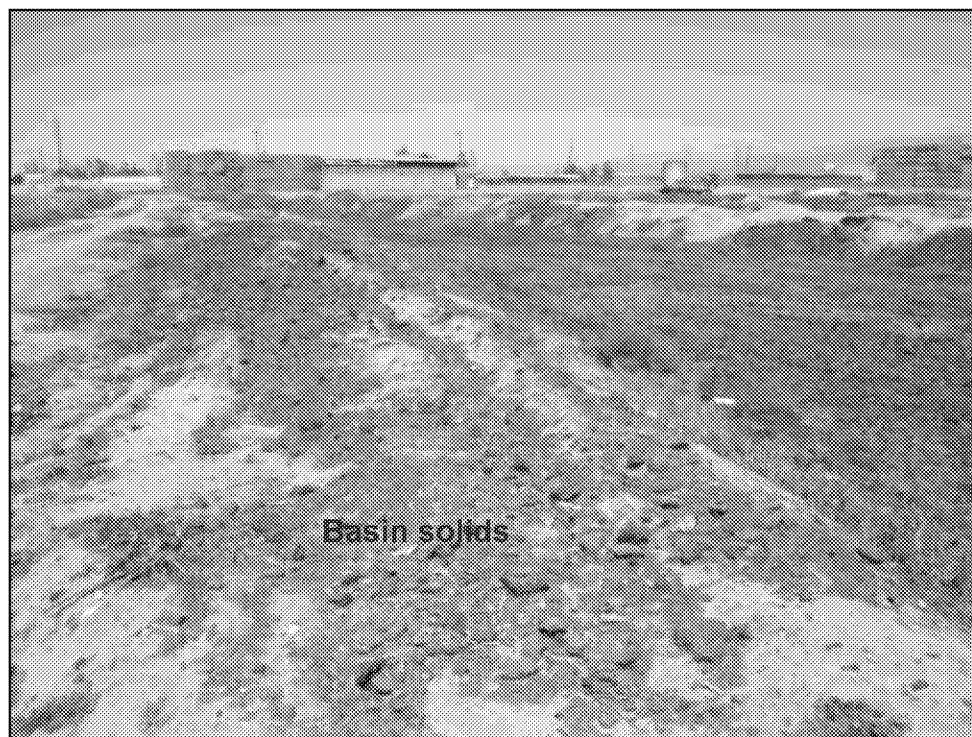
Photograph 8. View facing northwest of basin solids stockpiled on the earthen berm of the southern-most southern basin.

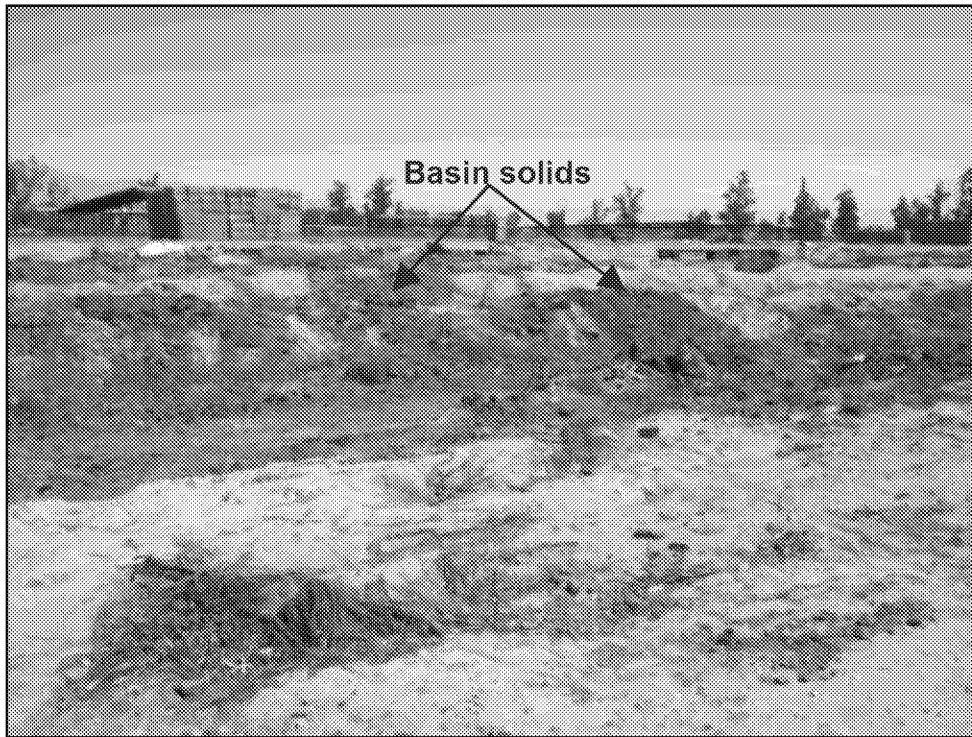
Photograph 9. View facing north of previously removed basin solids stockpiled on the earthen berm of the southern-most southern basin.

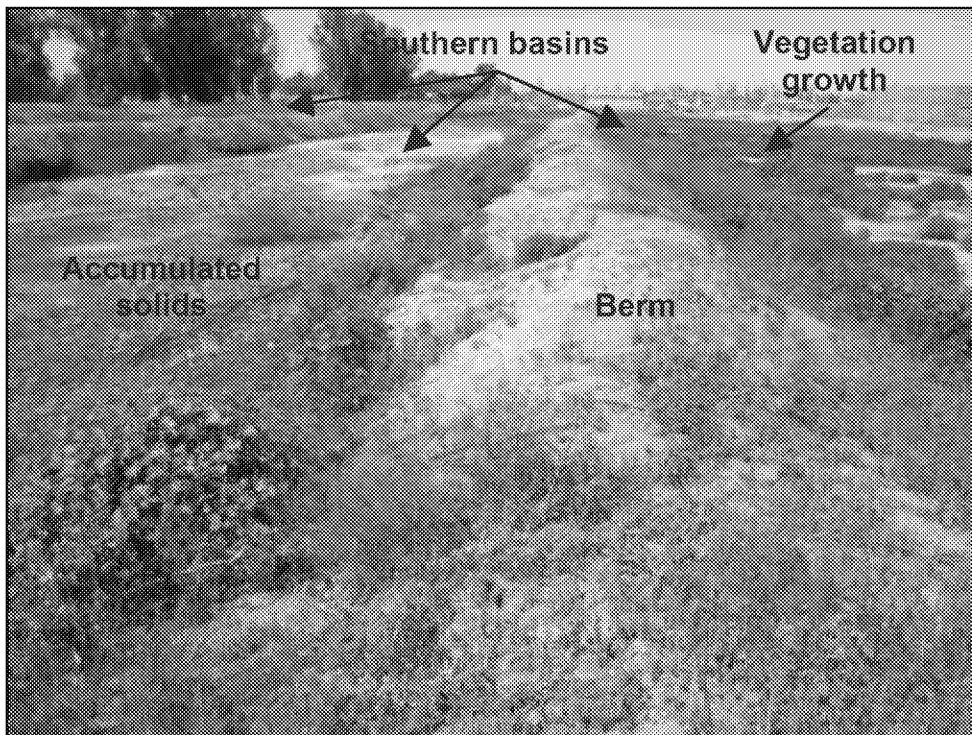
Photograph 10. View facing west of vegetation growth and accumulated solids on the east side of the southern basins.

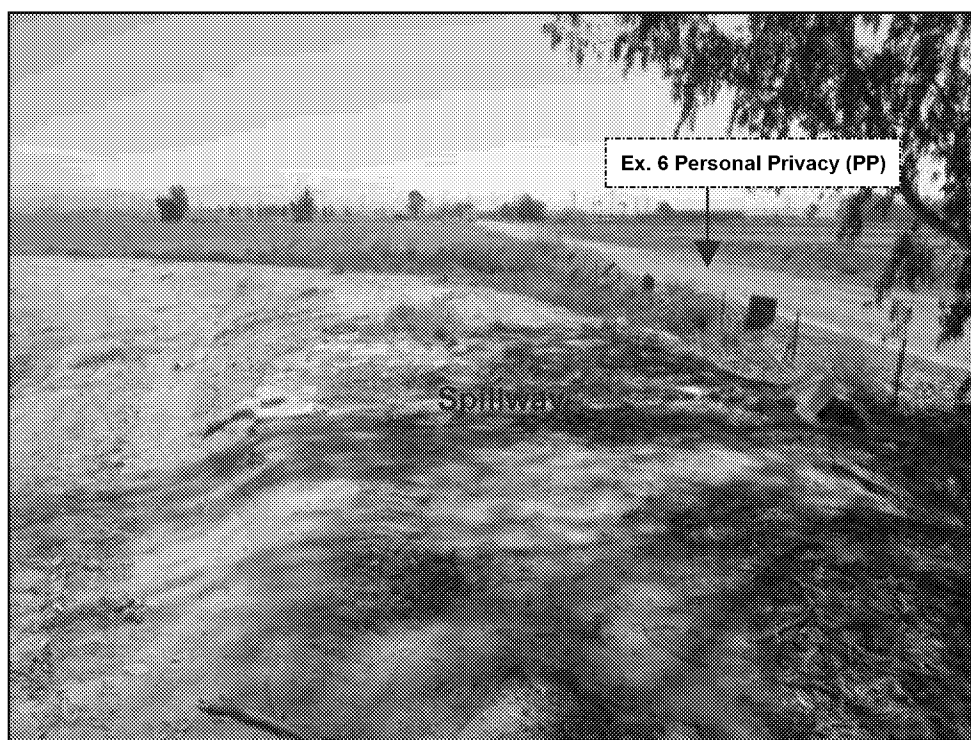
Photograph 11. View facing east of the spillway located in the southeast corner of the Facility, adjacent to the east side of the southern basins.

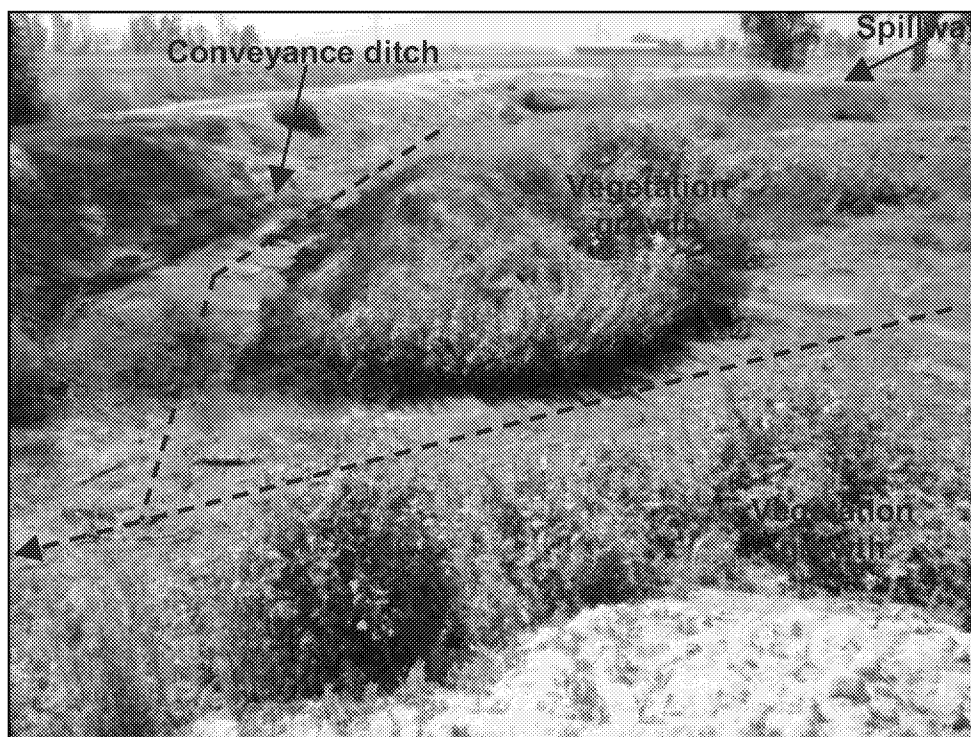
Photograph 12. View facing south of the process wastewater flow pathway from a southern basin into the conveyance ditch along the east side of the Facility. Note the vegetation growth.

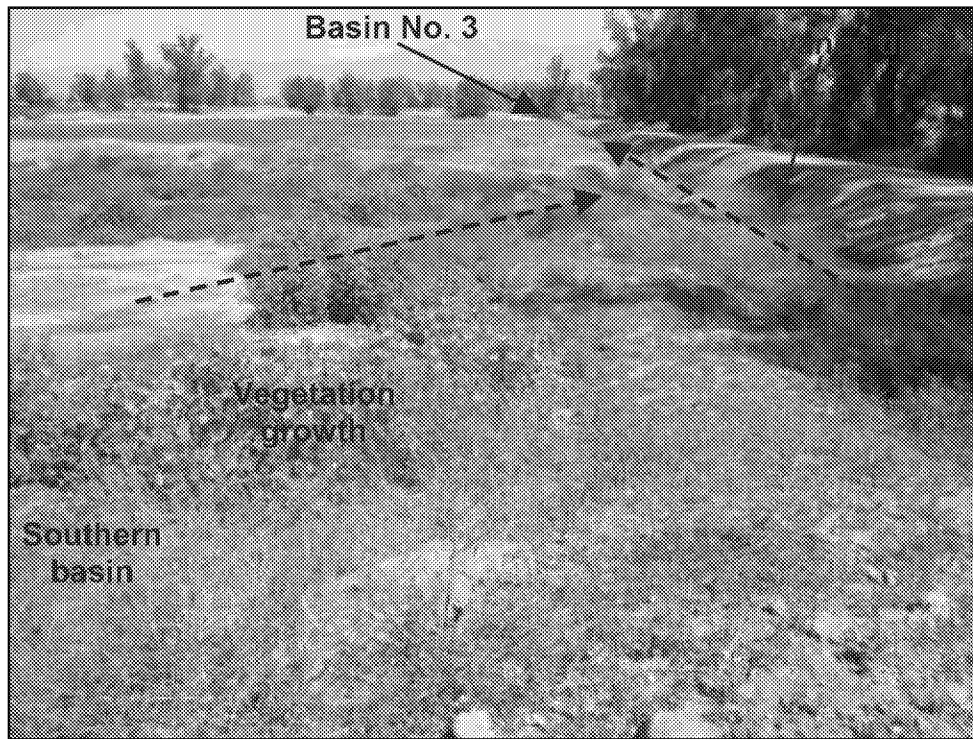
7. Accumulated solids and vegetation growth was observed in the Facility containment structures located in the southern and eastern portions of the Facility (refer to Photos 4 through 7, 10, 12, and 13). The Discharger must design and maintain all containment structures per the EWMP as required by Provision VII.C.3.a of the Permit.

Photograph 13. View facing north of the process wastewater flow pathway from a southern basin into the conveyance ditch along the east side of the Facility. Note the vegetation growth.

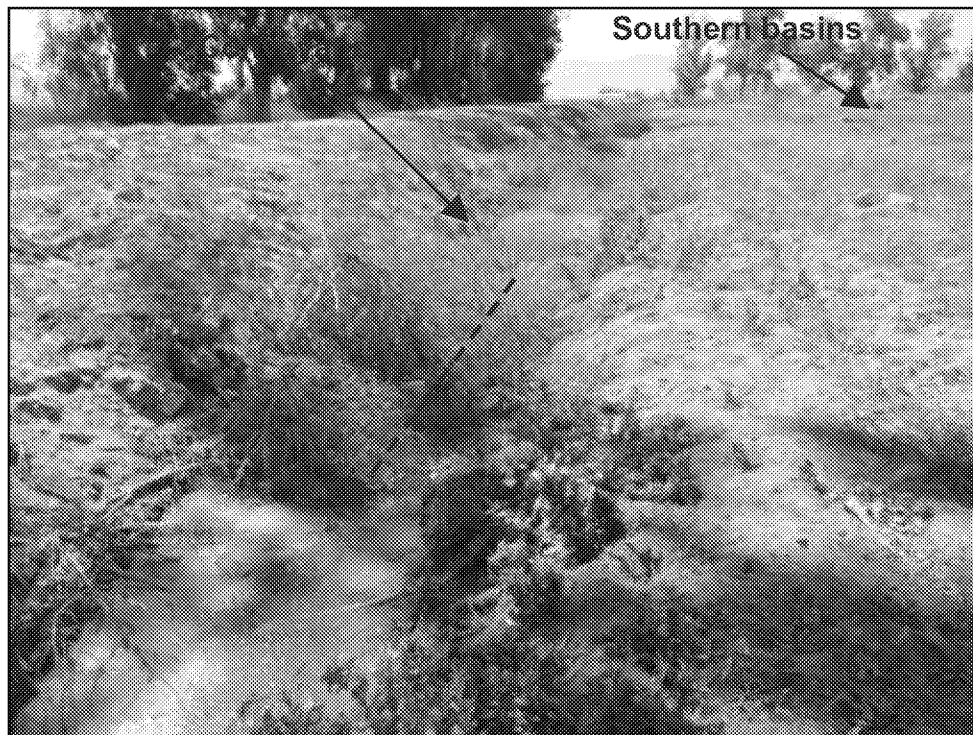
4. The EWMP was not reflective of current Facility conditions (i.e., containment structures) at the time of the inspection as required by Provisions VII.C.3.b of the Permit (refer to Photos 4 through 7, 10, 12, 13, and 14).

Photograph 14. View facing south of the conveyance ditch along the east side of the Facility. The conveyance ditch conveys process wastewater from the southern basins to basin No. 3.

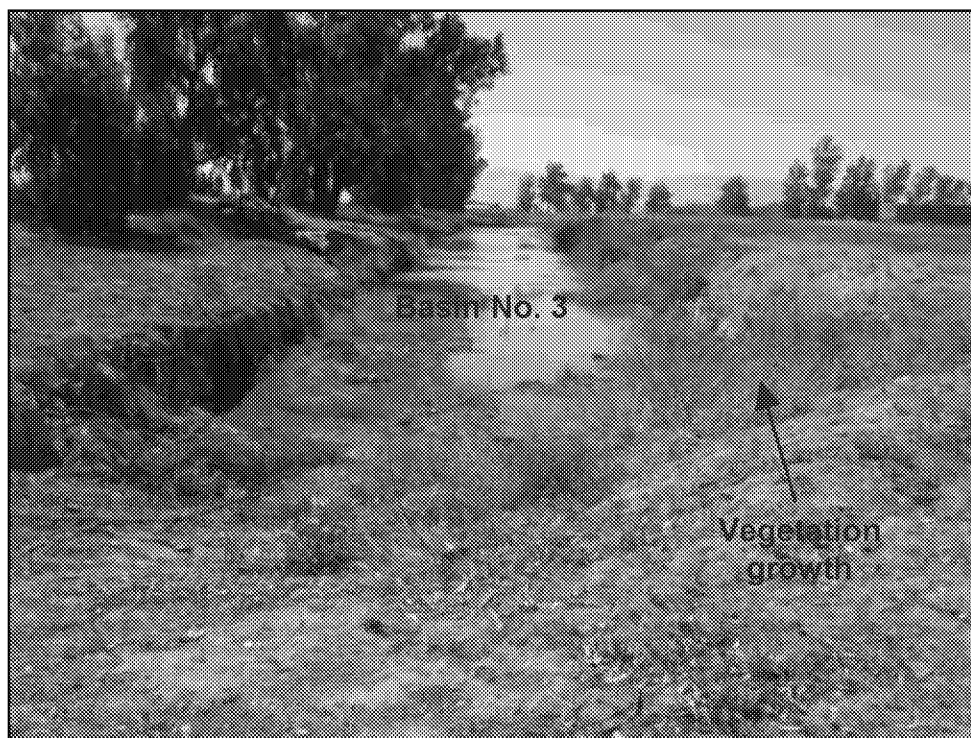
1. The inspector observed, during the inspection, that depth markers had not been not installed in all ponds and impoundments at the Facility as required by the Permit. Specifically, depth markers were not installed in basin No. 3 located in the northeast corner of the Facility, or in the four (4) basins located in the southern portion of the Facility (refer to Photos 4 through 7, and 15). It should be noted that the four (4) basins located in the southern portion of the Facility were not identified in the EWMP, but rather, are shown as field No. 1, basin No. 1, and the southern half of basin No. 2 on the EWMP Site Plan (refer to Exhibit 1). Mr. Vander Meulen stated that the Facility had always had the basins located in the southern portion of the Facility, and was unaware of the discrepancies with the approved EWMP Site Plan. Permit Attachment B - Monitoring and Reporting Program, Section I.B.1 states that "a marker shall be placed within each pond or impoundment to indicate the minimum capacity necessary to contain the runoff and direct precipitation of the 25-year, 24-hour rainfall event."

Photograph 15. View facing south of basin No. 3 located in the northeast corner of the Facility. Note vegetation growth was observed on the basin embankments. Also note the basin did not contain a depth marker.

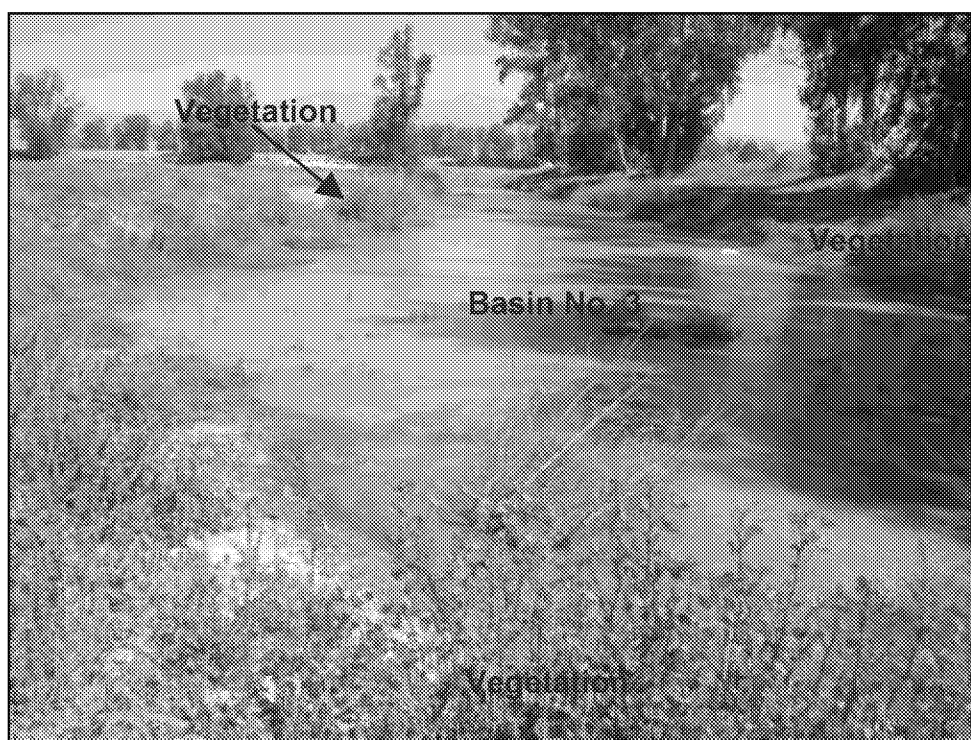
Photograph 16. View facing south of basin No. 3 located in the northeast corner of the Facility. Note vegetation growth was observed on the basin embankments.

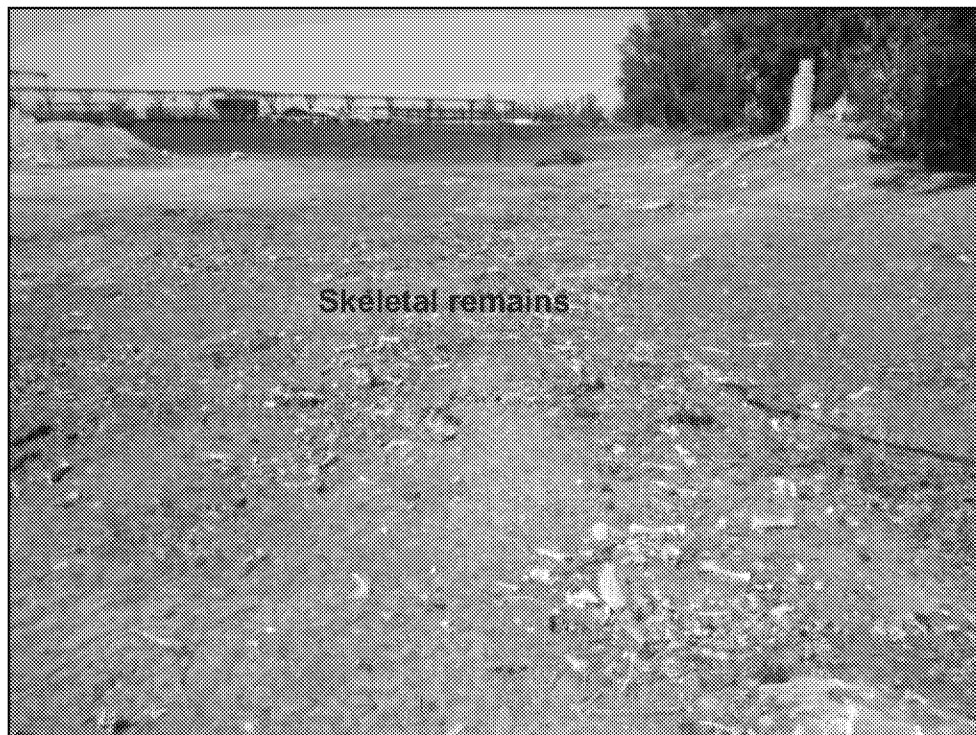
1. The inspector observed, during the inspection, skeletal remains (i.e., livestock mortalities) on the north side of field No. 3, northwest of basin No. 3 (refer to Photos 18 through 22). The skeletal remains appeared to be contained onsite; however, storm water runoff from field No. 3 most likely would flow southeast and enter basin No. 3. Mr. Vander Meulen stated that all skeletal remains are the result of coyotes killing new born calves and dragging them east into field No. 3. Discharge Prohibition IV.F of the Permit states "the disposal of any mortality in any process wastewater system is prohibited. Mortalities shall be handled in such a way as to prevent the discharge of pollutants to waters of the state."

Photograph 18. View facing west of skeletal remains and mortality debris on the north side of field No. 3, east of the northern corrals.

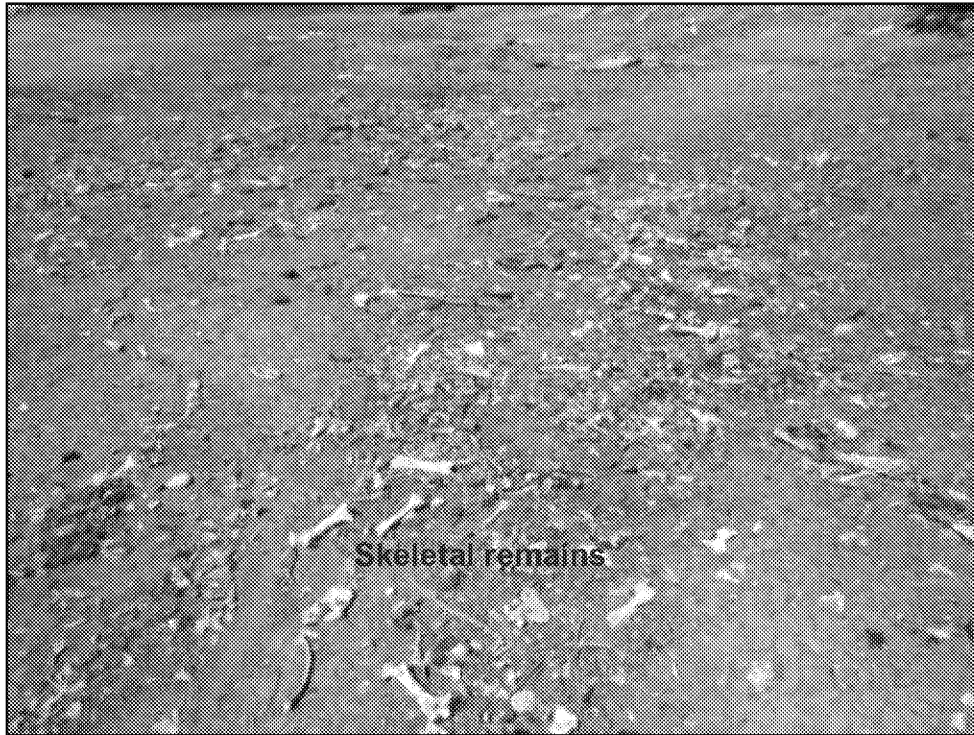
Photograph 19. Close-up view of the skeletal remains shown in Photograph 19.

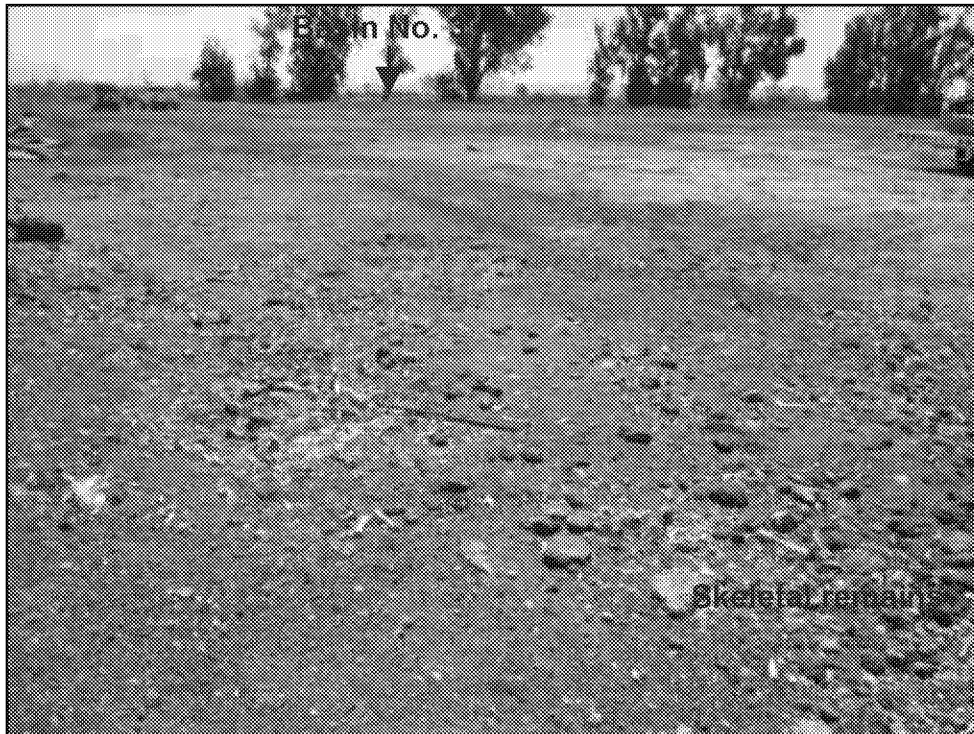
Photograph 20. View facing east skeletal remains and mortality debris on the north side of field No. 3, shown in Photographs 18 and 19, west of basin No. 3.

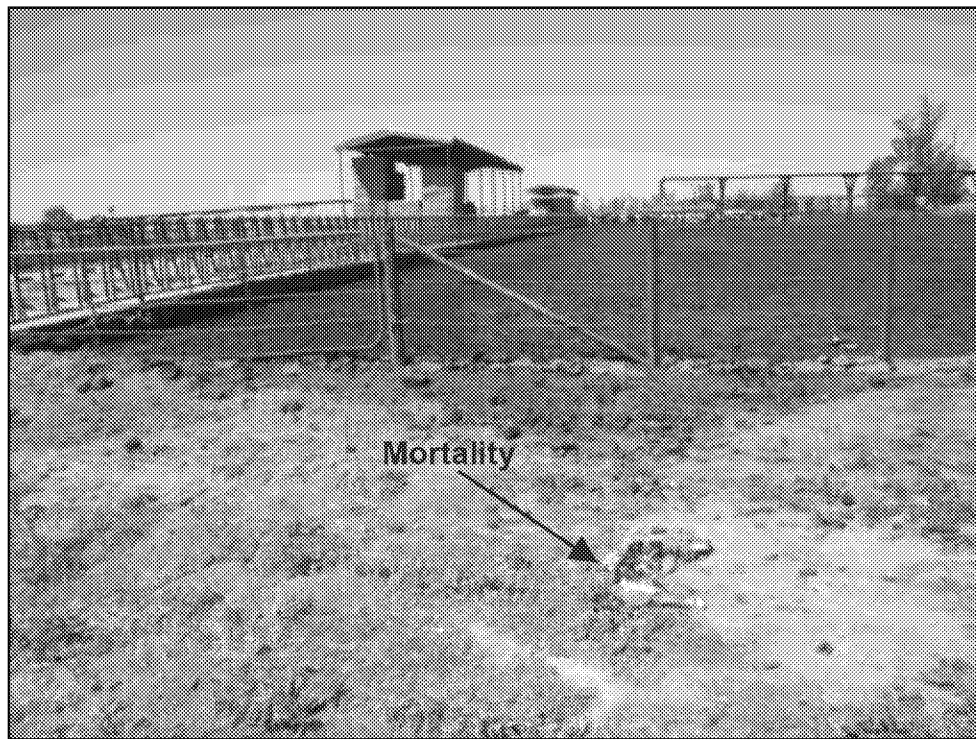
Photograph 21. View facing west of a mortality observed on the east side of the northern corrals.

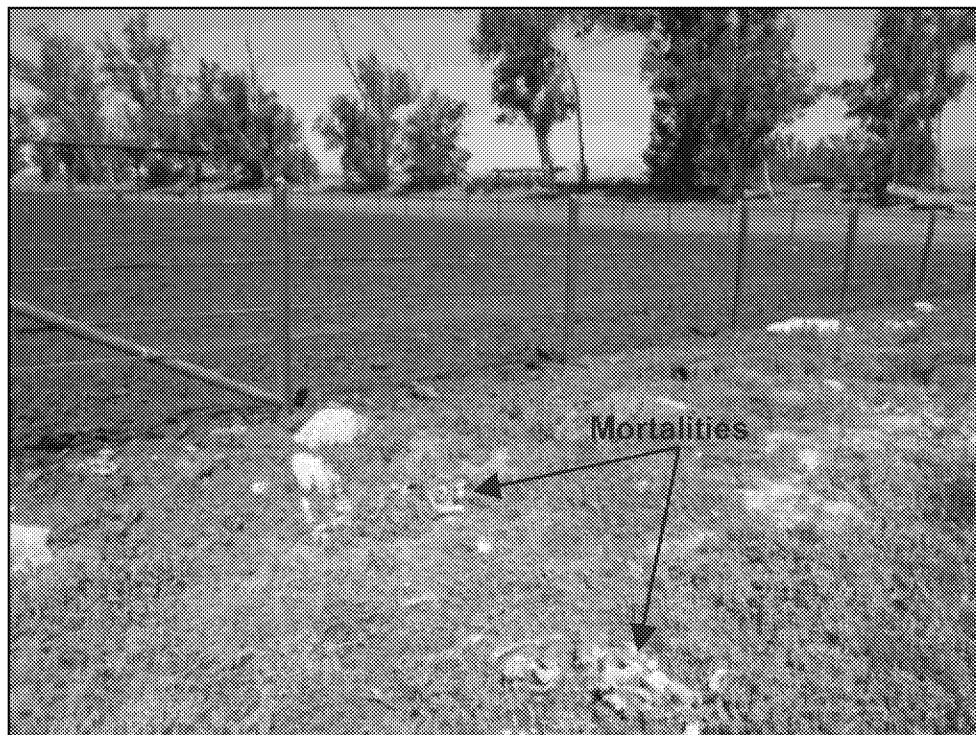
Photograph 22. View facing northwest of mortalities observed on the east side of the northern corrals.

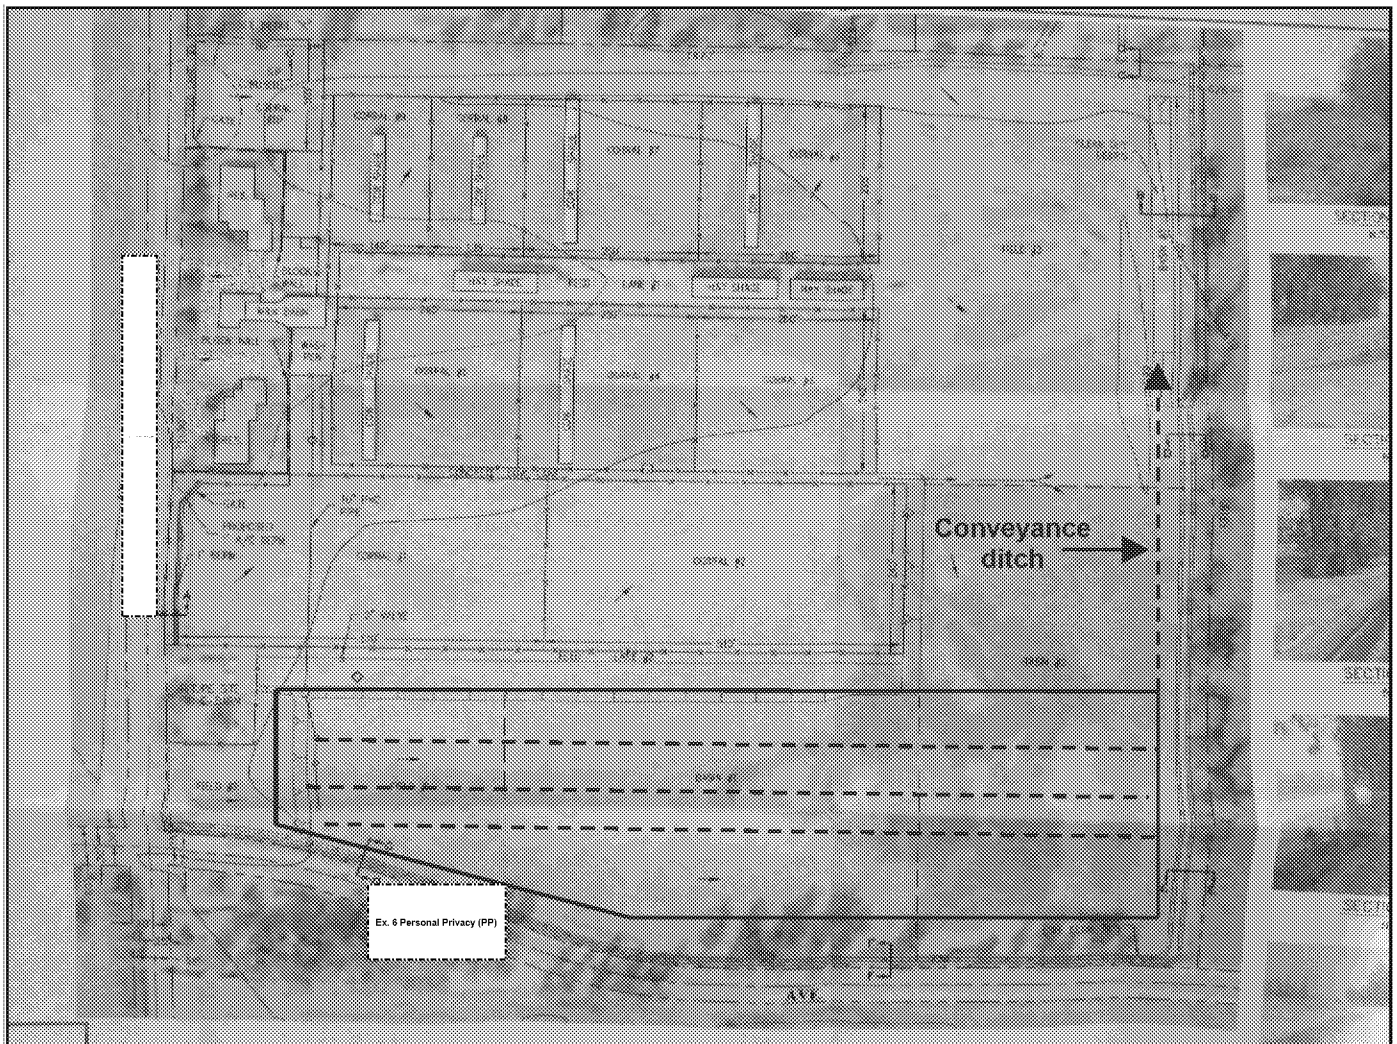
2. The EWMP was not representative of current Facility conditions at the time of the inspection as required by the Permit. Specifically, the approved EWMP and Site Plan identifies that process wastewater is land applied via four (4) check valves onto field No. 1 located in the southwestern portion of the Facility, and flows south through basin Nos. 1 and 2. The inspector observed, during the inspection, that four (4) additional basins had been constructed in field No. 1, basin No. 1, and the southern half of basin No. 2 (refer to Exhibit 1). East/west earthen berms had been constructed creating four (4) additional rectangular basins (refer to Photos 4 through 7, and 10). All four basins flow into a conveyance ditch on the east side of the Facility that flows north into basin No. 3 located in the northeast corner of the Facility (refer to Photos 12, 13, and 14). The conveyance ditch was also not identified on the approved EWMP or Site Plan. Mr. Vander Meulen stated that the Facility had always had the basins located in the southern portion of the Facility, and was unaware of the discrepancies with the EWMP and Site Plan. As a result of the additional basins and process wastewater conveyance ditch, the Discharger was not fully implementing the approved EWMP. Provision VII.C.3.b of the Permit states that "the discharger shall develop and fully implement an Engineered Waste Management Plan (EWMP) acceptable to the Executive Officer." The Discharger shall fully implement the EWMP as required by Provision VII.C.3.b of the Permit. This finding was previously identified during an inspection conducted on January 19, 2012.

Exhibit 1. TIVA Dairy approved EWMP Site Plan. Note four (4) east/west basins were constructed on the south side of the Facility in field No. 1, basin No. 1, and the southern half of basin No. 2. It should be noted that these additional basins were not in accordance with the approved EWMP and Site Plan.
